ROAD BRIDGES - NEW REHABILITATION MATERIALS AND TECHNOLOGIES

A PIARC TECHNICAL REPORT

15.29. CASE 29: FATIGUE CRACKS IN A NON COMPOSITE STEEL GIRDER BRIDGE (JAPAN)

Answer	<p>Kaminagakubo Br. (Inbound & Outbound)</p> <ul style="list-style-type: none"> • Bridge type: 3+2+3 span continuous non-composite steel plate girder bridge • Bridge length: 300m • Main span: 37.5m • Completion year: 1969
Picture of the bridge

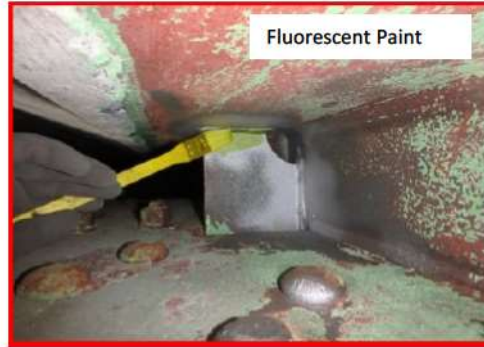
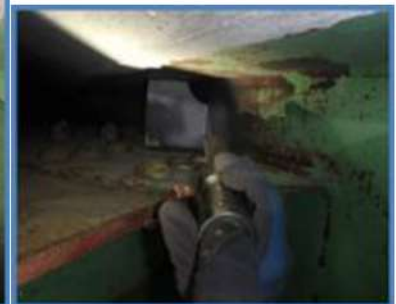
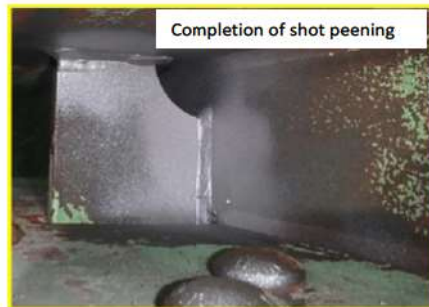
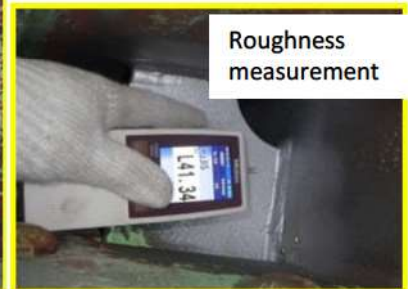
Picture

Answer	Because of aging and heavy traffic, it was decided to take countermeasures against fatigue crack from the point of view of preventive maintenance.

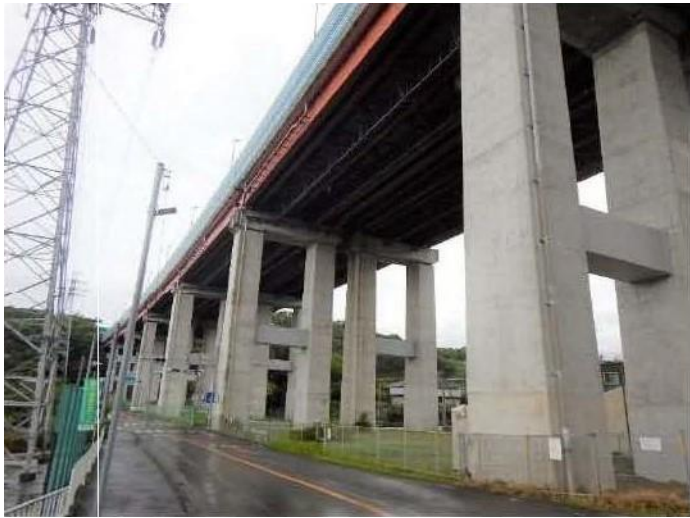
Case: 非合成鋼桁橋の疲労き裂(日本)	
I) 橋の簡単な説明 (タイプ、材質、工期等)	橋の種類、材料(鋼、鉄筋コンクリート、プレストレストコンクリート、材木、レンガなど)、建設時間、スパンの長さなどを含む、橋の簡単な説明。
回答	上長窪支店(上下線) 橋形式:3+2+3 径間連続非合成鋼桁橋 橋長 300m。 主径間 37.5m 竣工年:1969 年
橋梁の写真

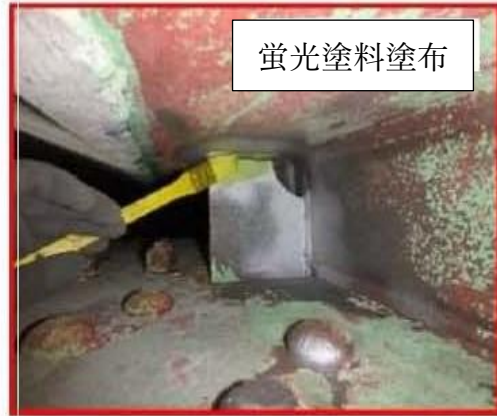
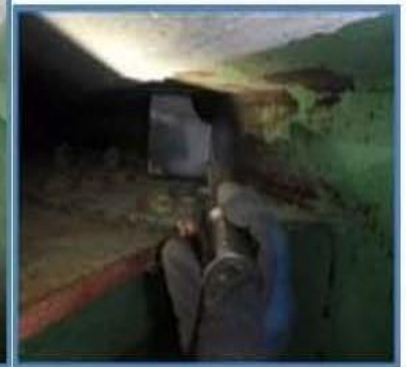
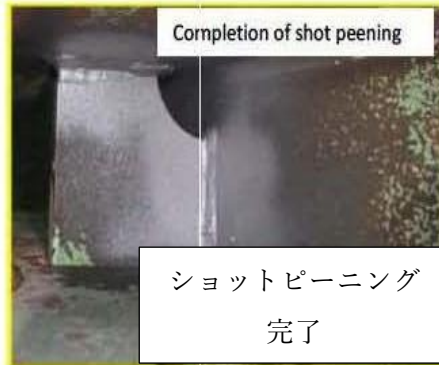
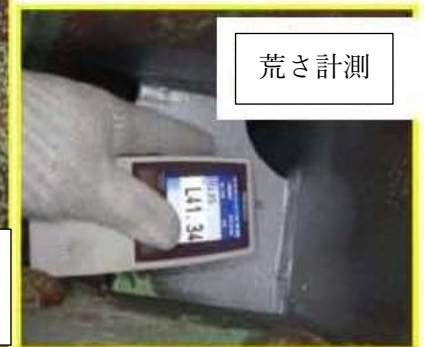
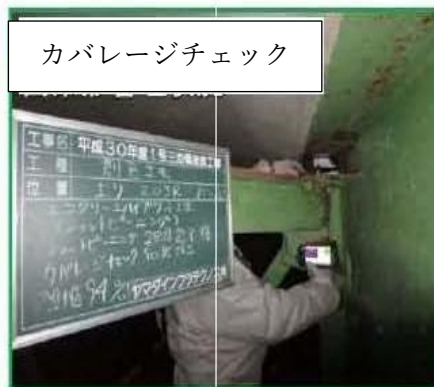
Picture

2a) リハビリテーションの必要性の簡単な説明	橋のリハビリテーションが必要な理由の説明 劣化(種類)、サービスレベルの向上(例えば、耐荷重)
回答	老朽化と交通量の多さから、予防保全の観点より疲労き裂対策を行うこととした。

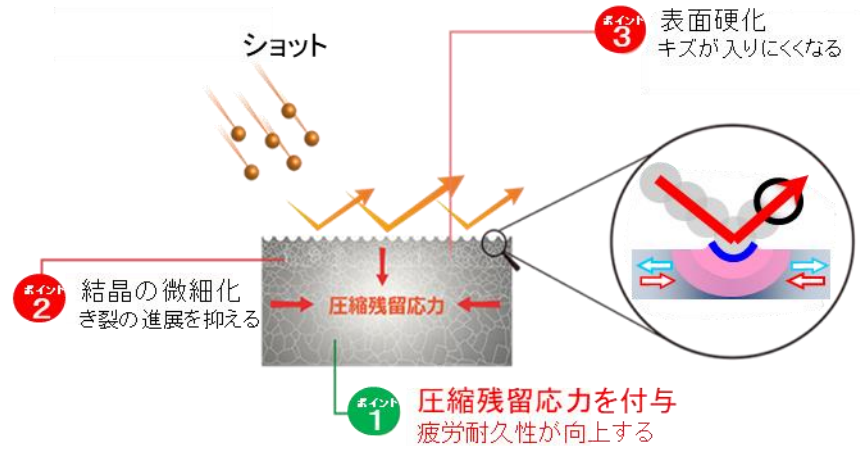
新しいリハビリ
テーション素材
と技術の写真

※図中の寸法は標準ガセット試験体のものである。

<p>2b) このリハビリテーションの必要性は、気候変動の影響と関係</p>	<p>リハビリテーションの必要性は気候変動の影響に関連しているか? 例:</p> <ul style="list-style-type: none"> ● 洪水のリスクが増大しているため、栈橋の洗掘保護を改善する。 ● 大雨が増えているので、排水能力を増やす。 ● 温度上昇のため、耐熱性の高い新しいアスファルト舗装を使用 <p>関連して居る場合は記載する</p>
<p>回答</p>	<p>関連していない</p>
<p>3a) 新しいリハビリテーション材料や技術について説明</p>	<p>リハビリテーションの素材や技術について簡単に説明する。 完成年</p>
<p>回答</p>	<p>ショットピーニングは、疲労耐久性と応力腐食割れの耐久性を向上させる技術です。ショットピーニングは、スチールグリットとスチールショットを用いて、鋼材表面に微小な塑性変形と有益な圧縮残留応力を与える表面処理である。表面の結晶粒を微細化することにより、亀裂の進展を防止します。また、表面を硬化させることにより、キズの発生を防止します。</p> <p>大規模な飛散防止対策が必要であることや、研削材の回収・再利用が困難であることなどから、橋梁現場ではなく工場でのみショットピーニングは適用されてきた。しかし、以下の対策により、既存の橋梁現場での適用が可能となった。</p> <ul style="list-style-type: none"> ● 塗替塗装工事と同時にショットピーニングを実施することで、塗替塗装の足場やブラスト飛散防止対策もショットピーニング時に利用することができる。 ● 新開発の循環式ブラストのシステムによりショットピーニング用ショットを回収し、再利用します。 ● 塗装用ブラストのスチールグリットをショットピーニング用の丸形スチールショットに交換する。 ● 確実な品質管理のための施工・仕上がり形状管理手法の開発した <p>2020年に改修工事が完了した。</p>
